FIBER OPTIC SENSORS
FOR THE PROTECTION AND CONSERVATION
OF CULTURAL HERITAGE

ONE SENSING TECHNOLOGY for a MULTIPURPOSE MONITORING

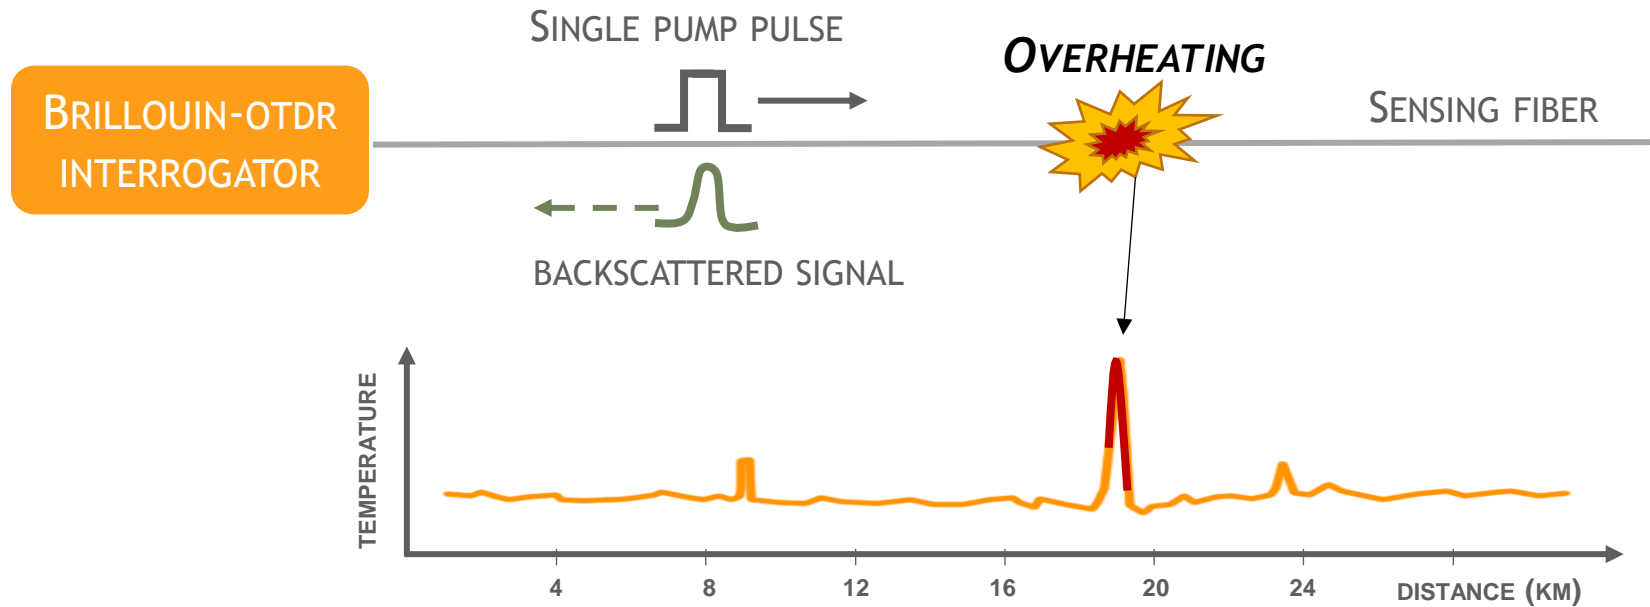
- OTDR APPROACH (RAMAN / BRILLOUIN TECHNOLOGY)

- A PUMP PULSE IS SENT INTO THE FIBER AND THE BACKSCATTERING SIGNAL GENERATED IN EACH SINGLE POINT OF THE FIBER IS ANALYZED.
- TEMPERATURE WITH METER SPATIAL RESOLUTION, ARE RECOVERED OVER TENS OF KM.

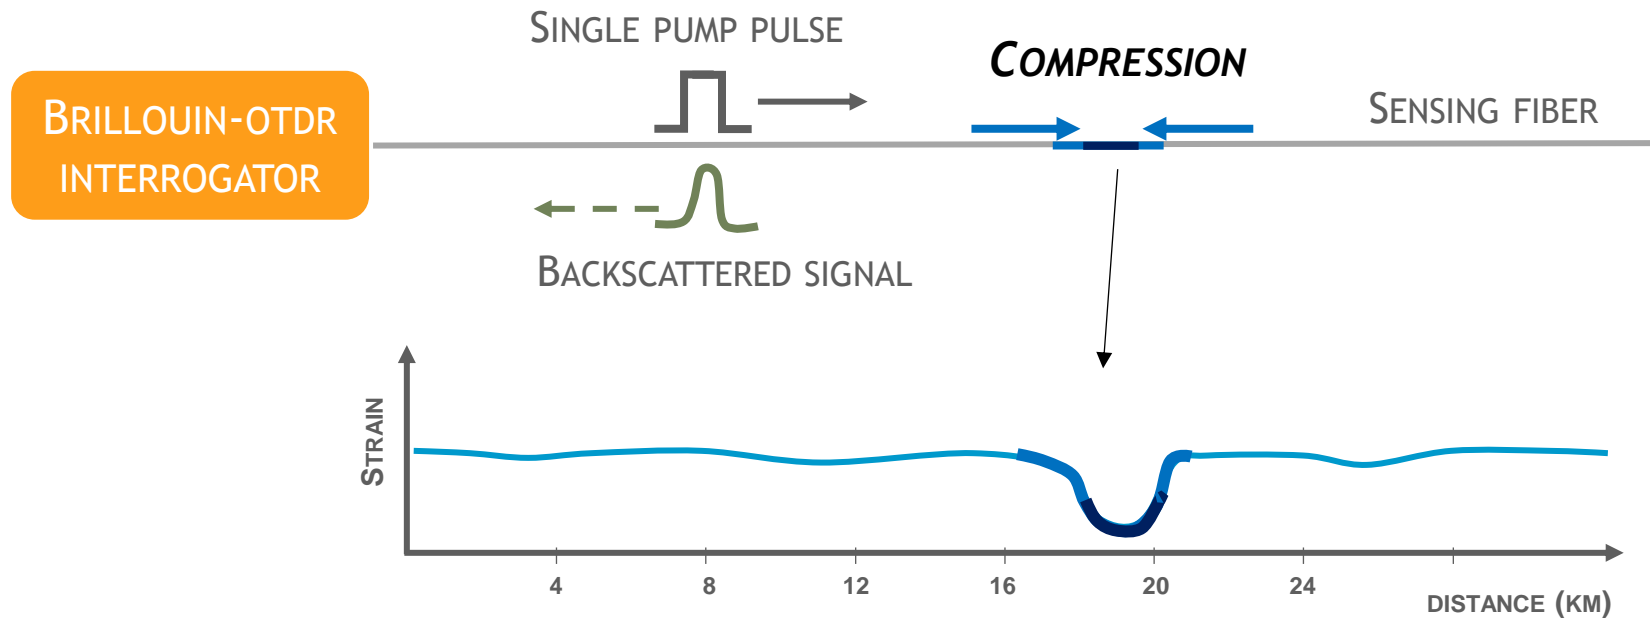
- OTDR APPROACH (BRILLOUIN /DAS TECHNOLOGY)

- A PUMP PULSE IS SENT INTO THE FIBER AND THE BACKSCATTERING SIGNAL GENERATED IN EACH SINGLE POINT OF THE FIBER IS ANALYZED.
- STRAIN OR VIBRATION PROFILES WITH 1 METER SPATIAL RESOLUTION OVER TENS OF KM CAN BE RECOVERED.

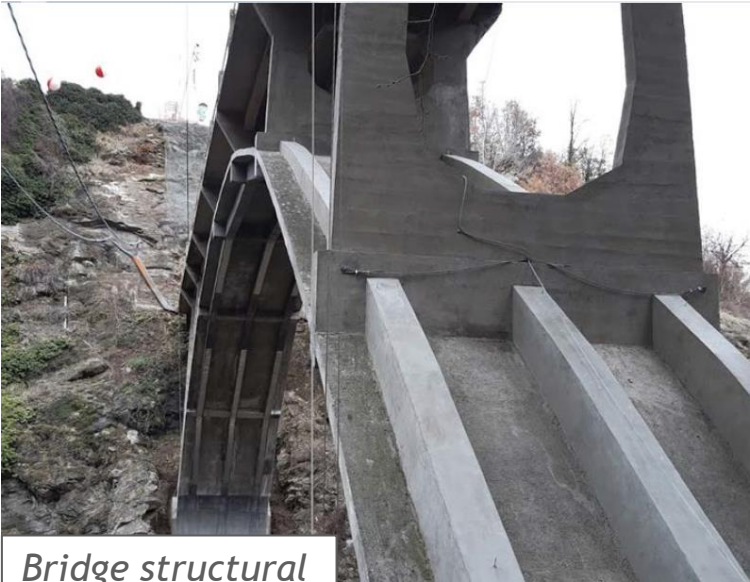
Bridge structural health diagnostic

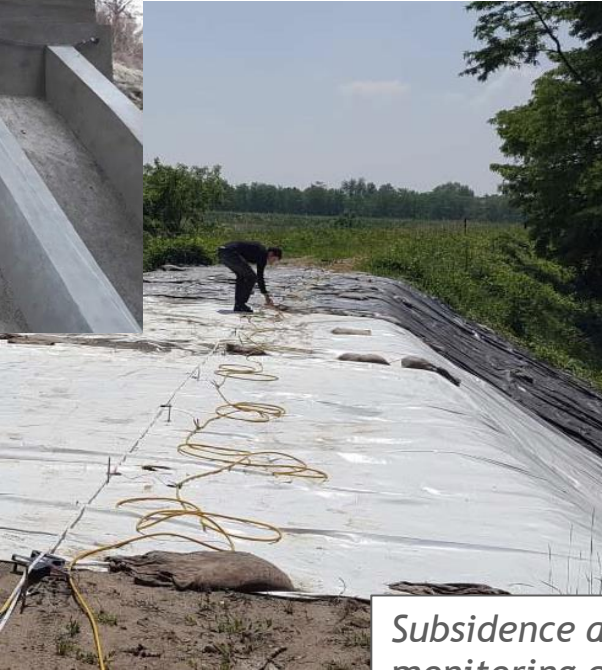
Subsidence and infiltration monitoring along levees

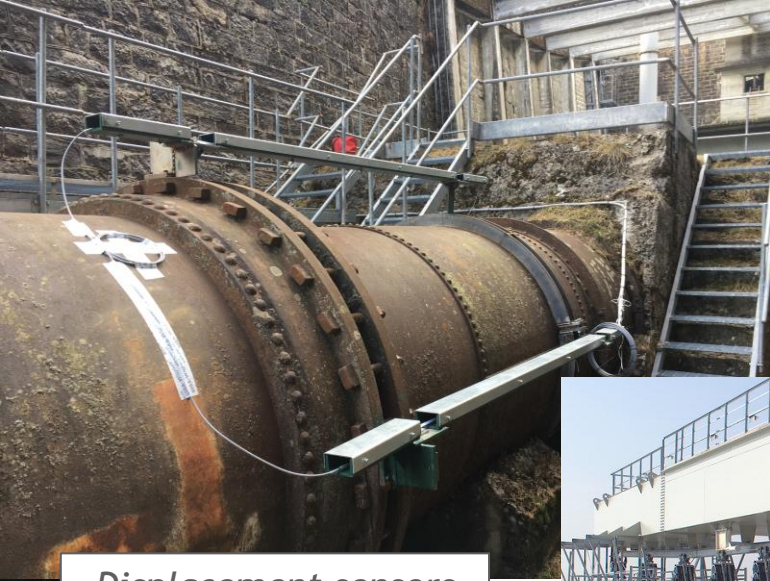
Displacement sensors along a water pipe on a landslide

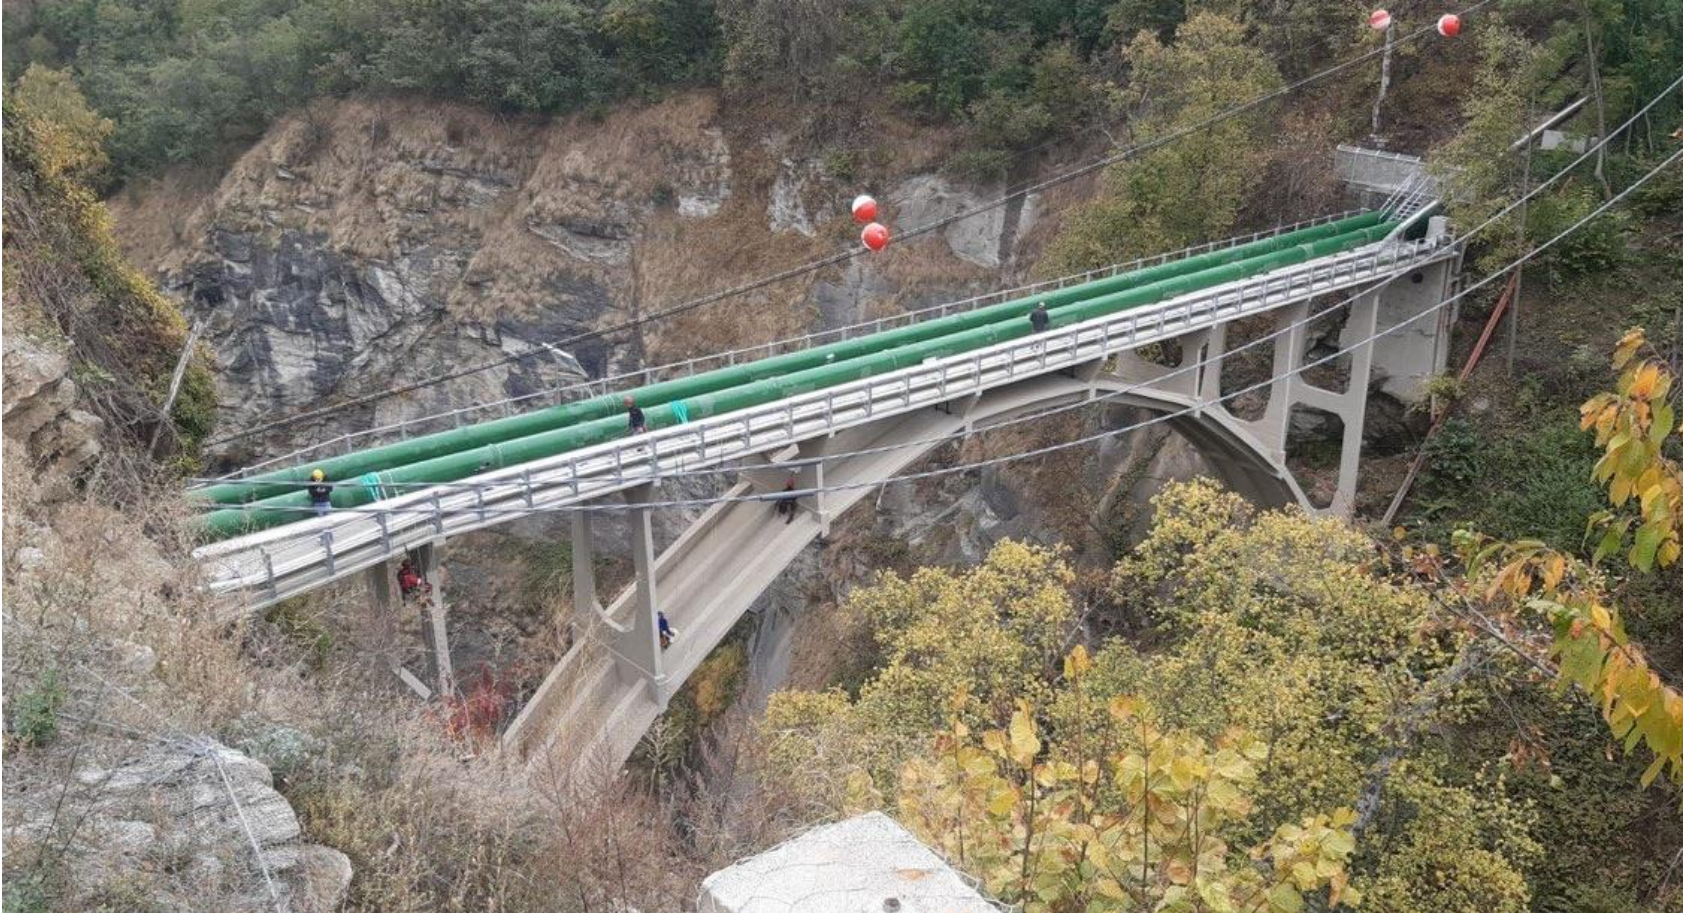
STRUCTURAL HEALTH MONITORING OF A HISTORICAL WATER PENSTOCK BRIDGE POSITIONED OVER THE DORA DI RHÊMES CANYON (INTROD) IN VALLE D'AOSTA REGION, REPRESENTING ONE OF THE FIRST EXAMPLES OF A CONCRETE BRIDGE BUILT IN THE 1920s.

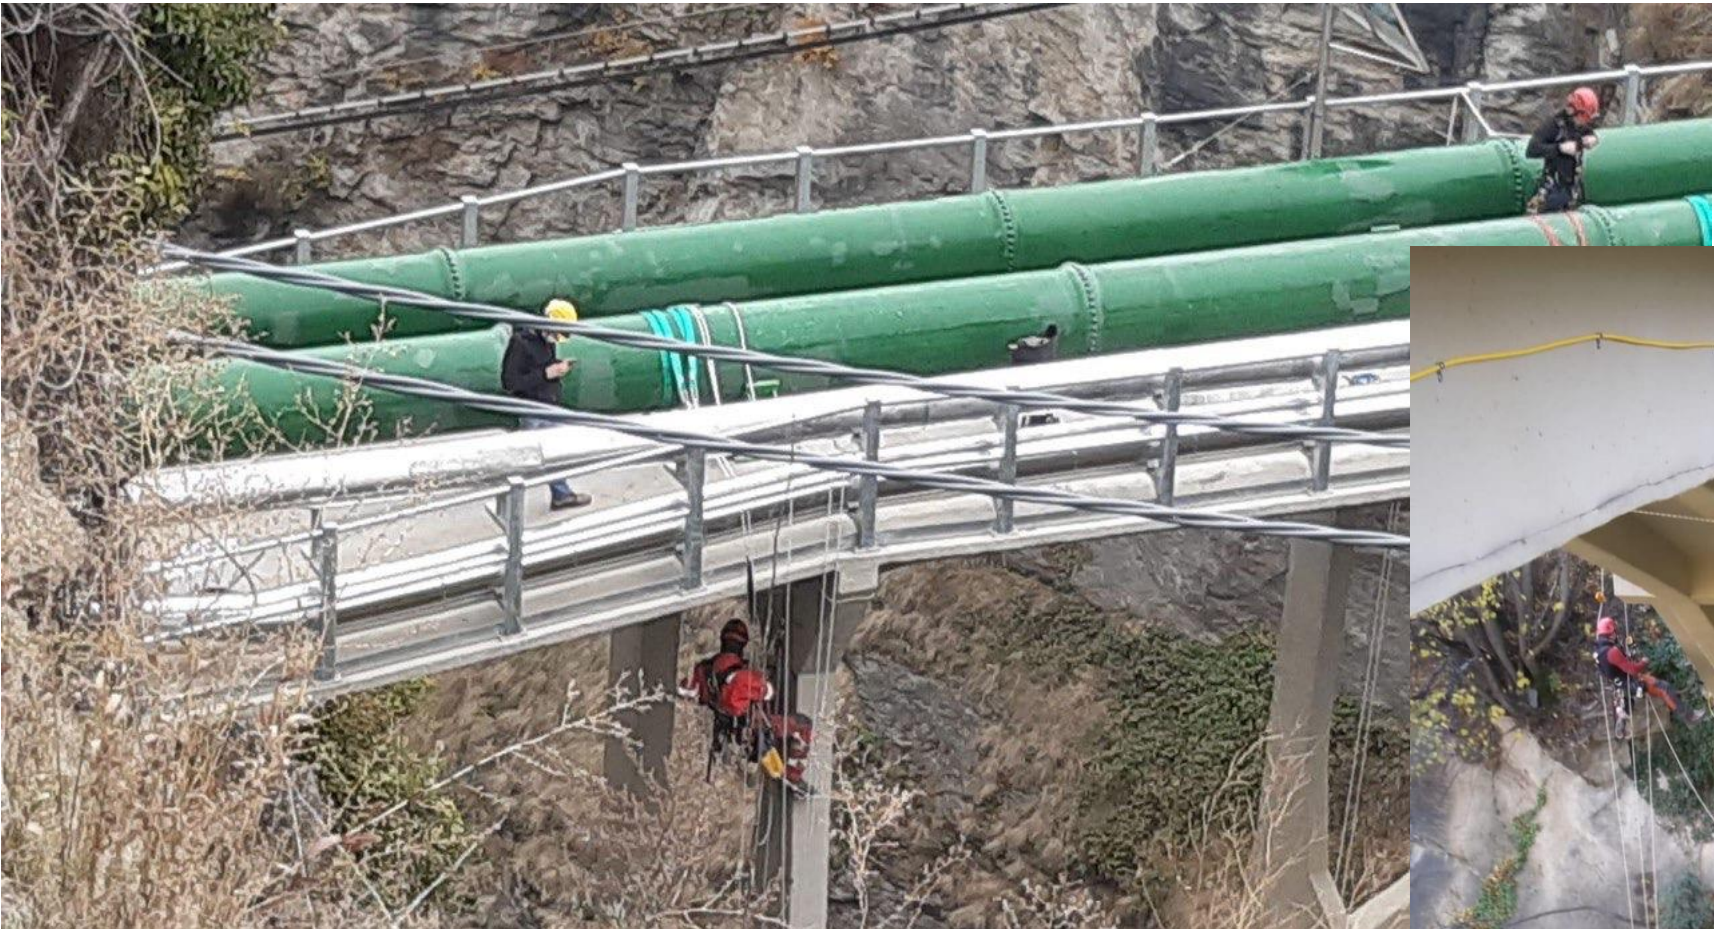
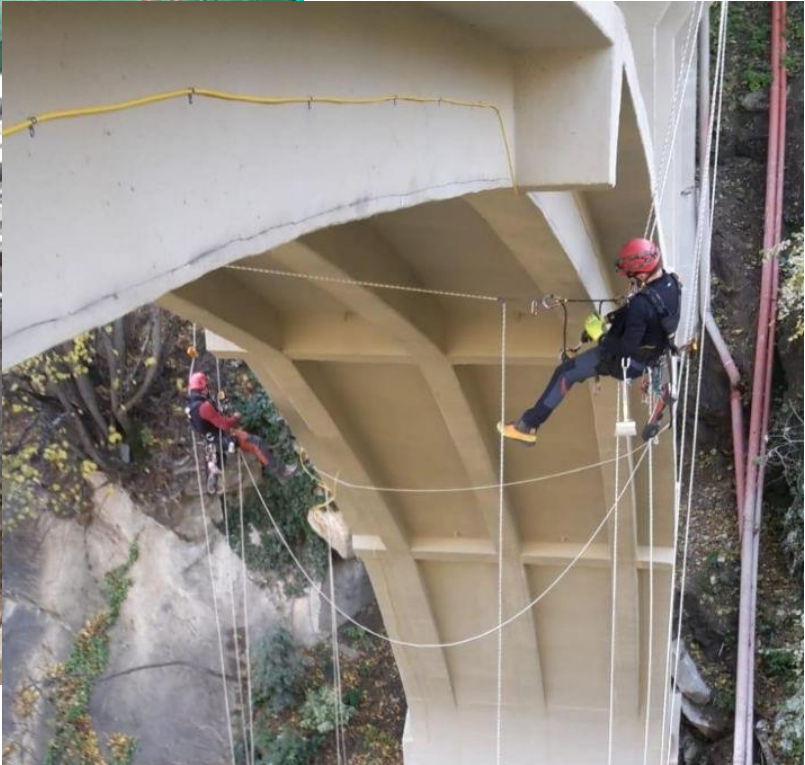
SENSING FIBER INSTALLATION ON THE BRIDGE TO MONITOR DEFORMATION INDUCED BY THE GEOLOGICAL MOVEMENTS OF THE SURROUNDING MOUNTAINS.

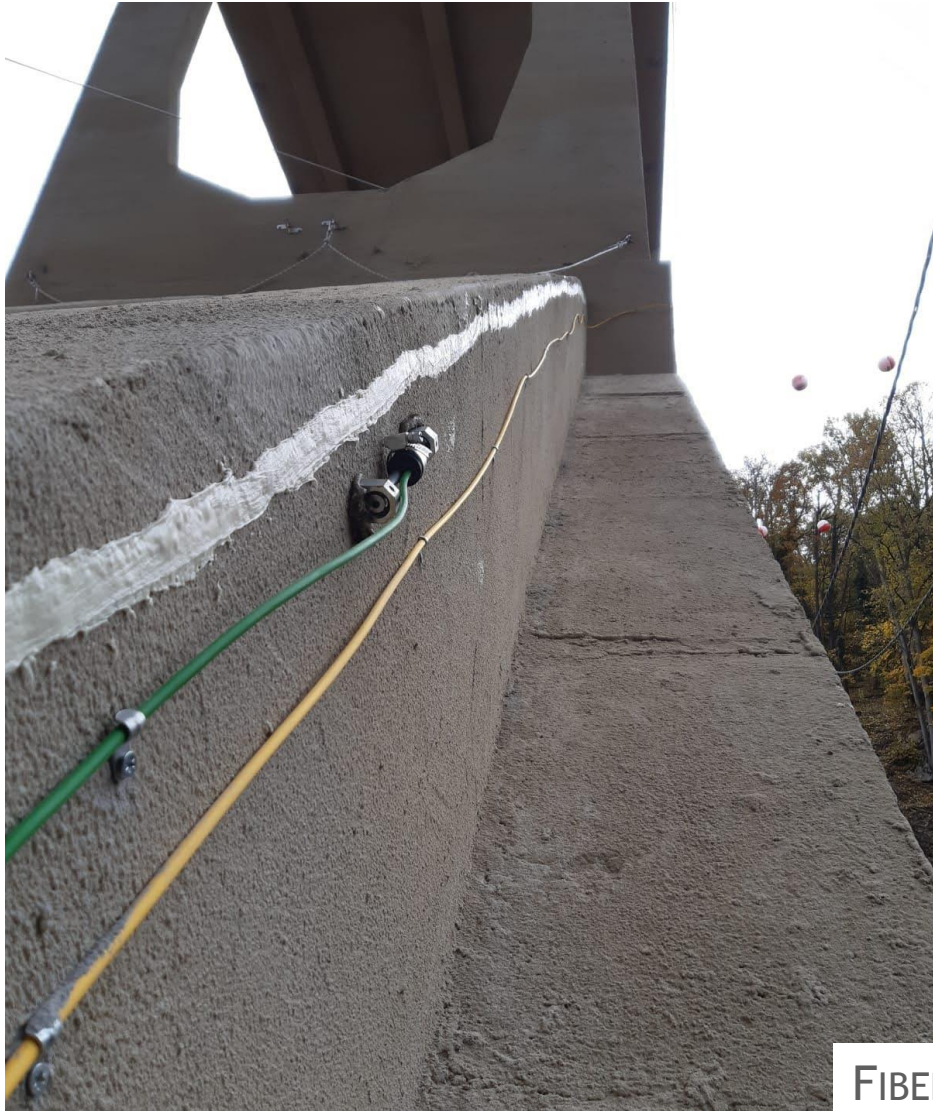
BRIDGE MONITORING PERFORMED WITH BOTH CONVENTIONAL STRAIN GAUGES AND ACCELEROMETERS AND FIBER OPTIC DISTRIBUTED SENSORS.

FIBER OPTIC DISTRIBUTED DEFORMATION SENSOR CEMENTED ON THE STRUCTURE

FIBER OPTIC DISTRIBUTED TEMPERATURE SENSOR

CONVENTIONAL STRAIN GAUGE

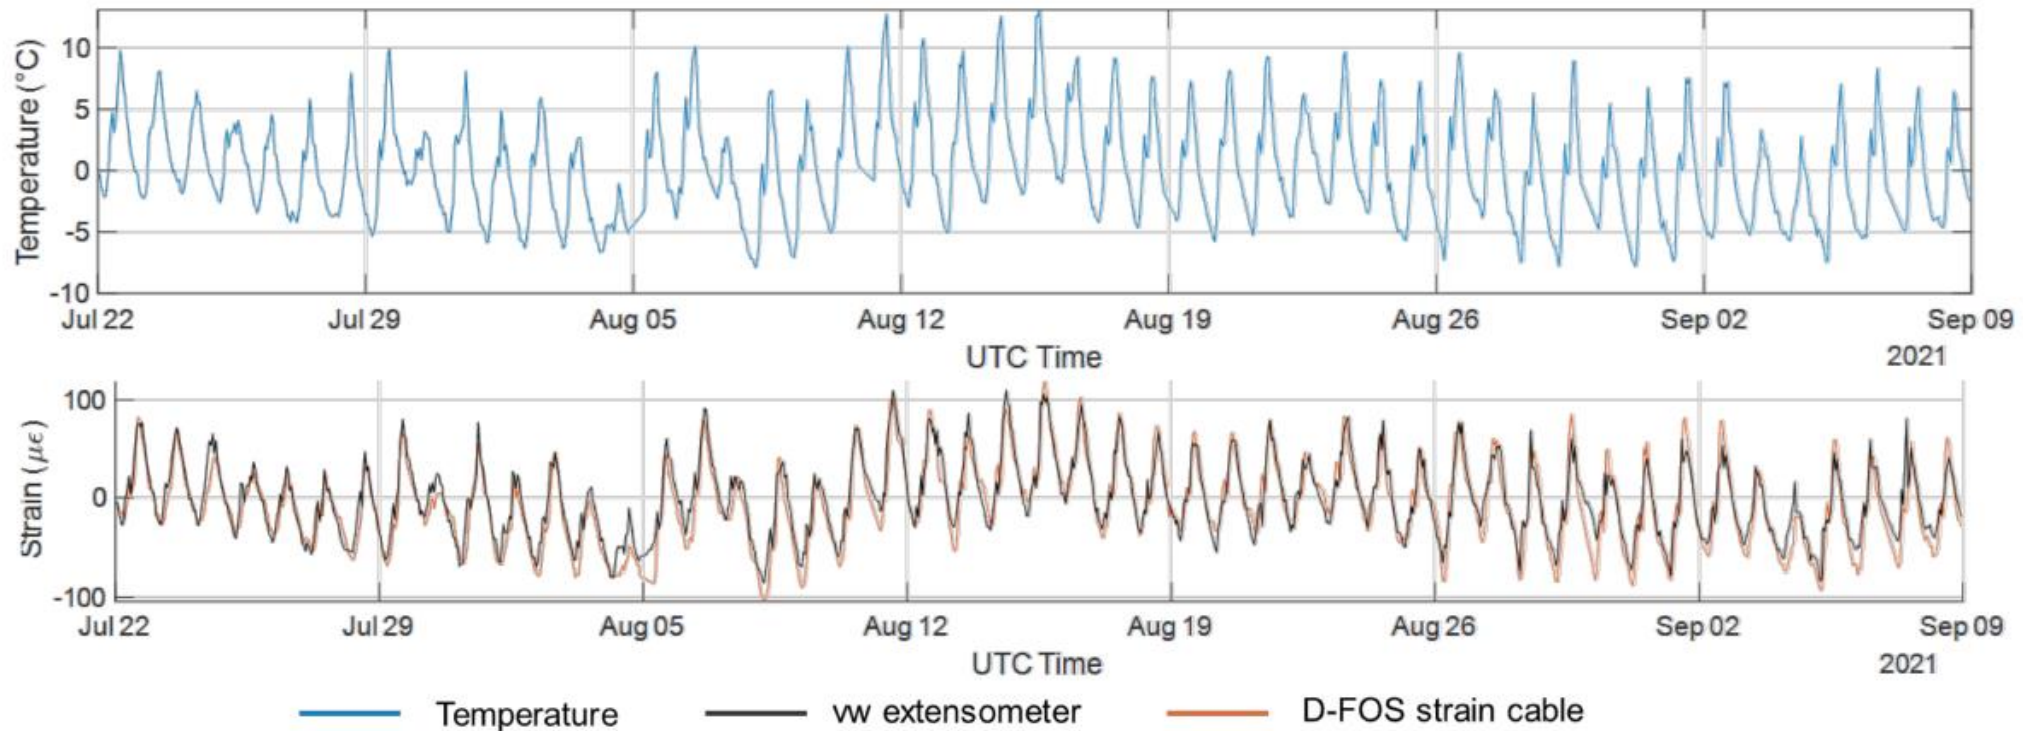
TEMPERATURE AND STRAIN MEASURES

COMPARISON OF THE STRAIN PROFILE OBTAINED RESPECTIVELY BY THE VW EXTENSOMETER AND THE FIBER STRAIN CABLE AT POSITION A1 (FORM 22 JULY 2021 TO 9 SEPTEMBER 2021).

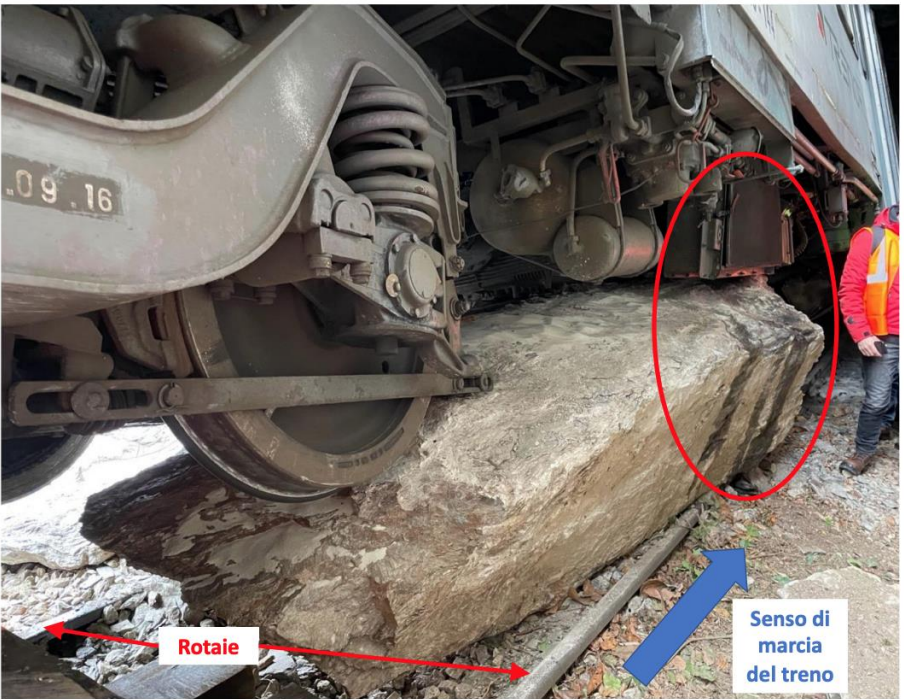
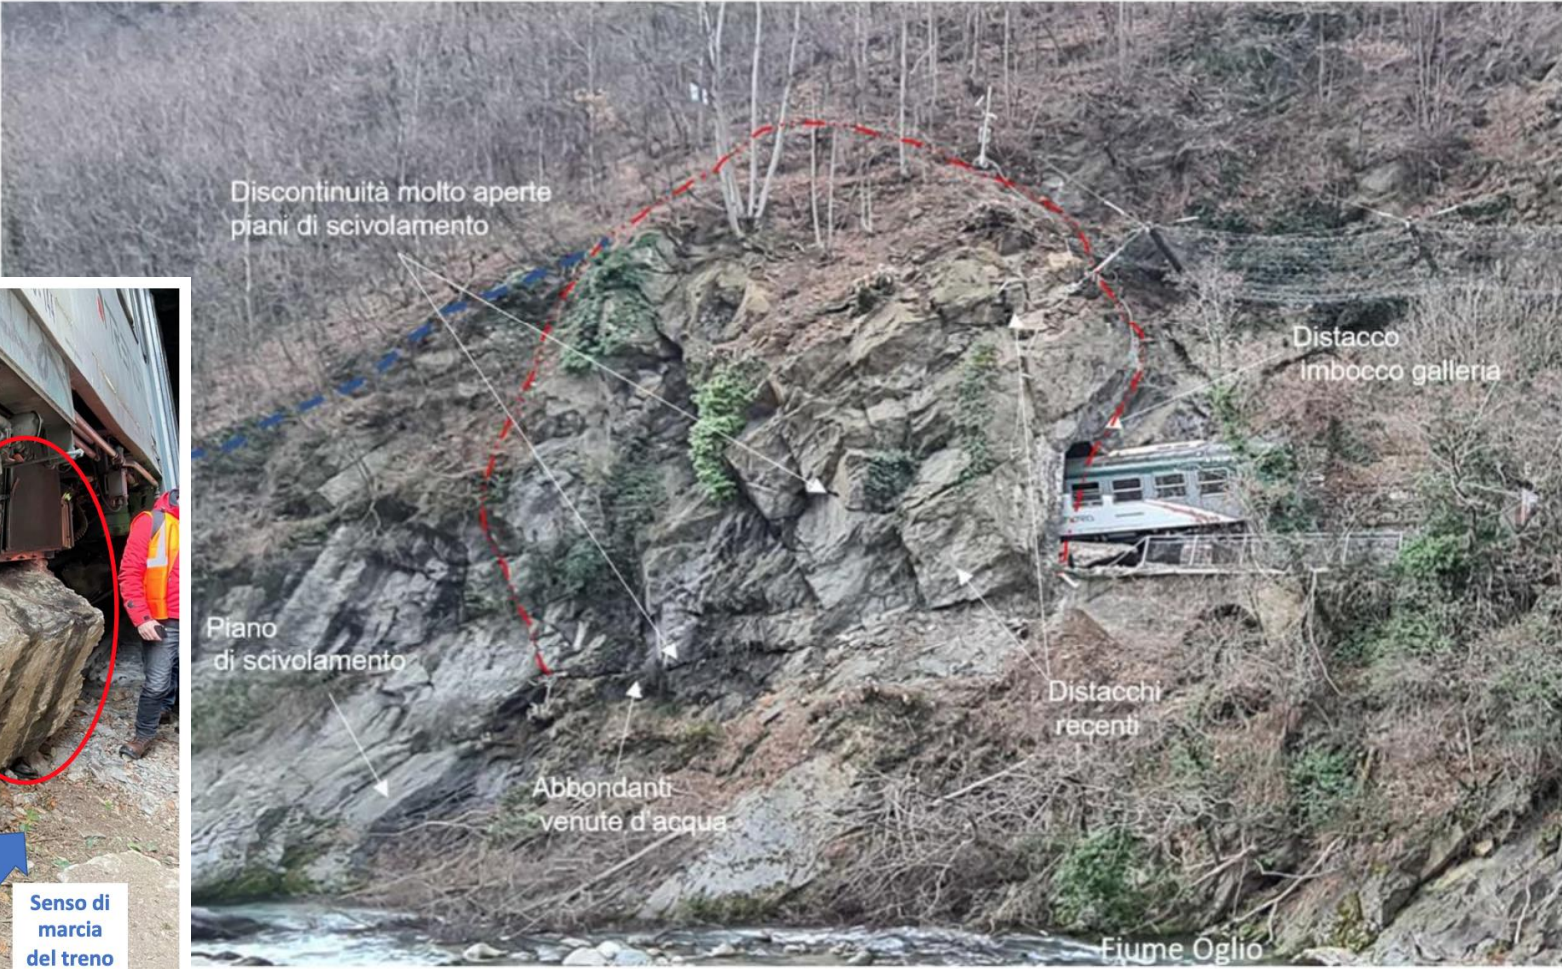
DECEMBER 2021: ROCKFALL AT THE ENTRANCE TO A NATURAL TUNNEL ON THE BRESCIA-EDOLO RAILWAY TRACK DUE TO INSTABILITY OF THE MOUNTAIN SIDE.

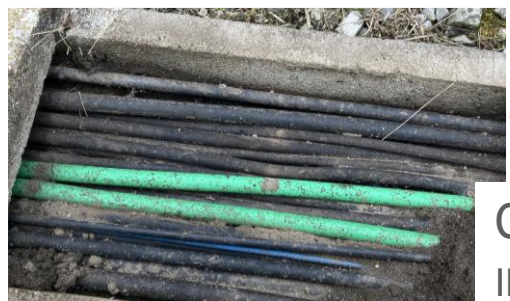
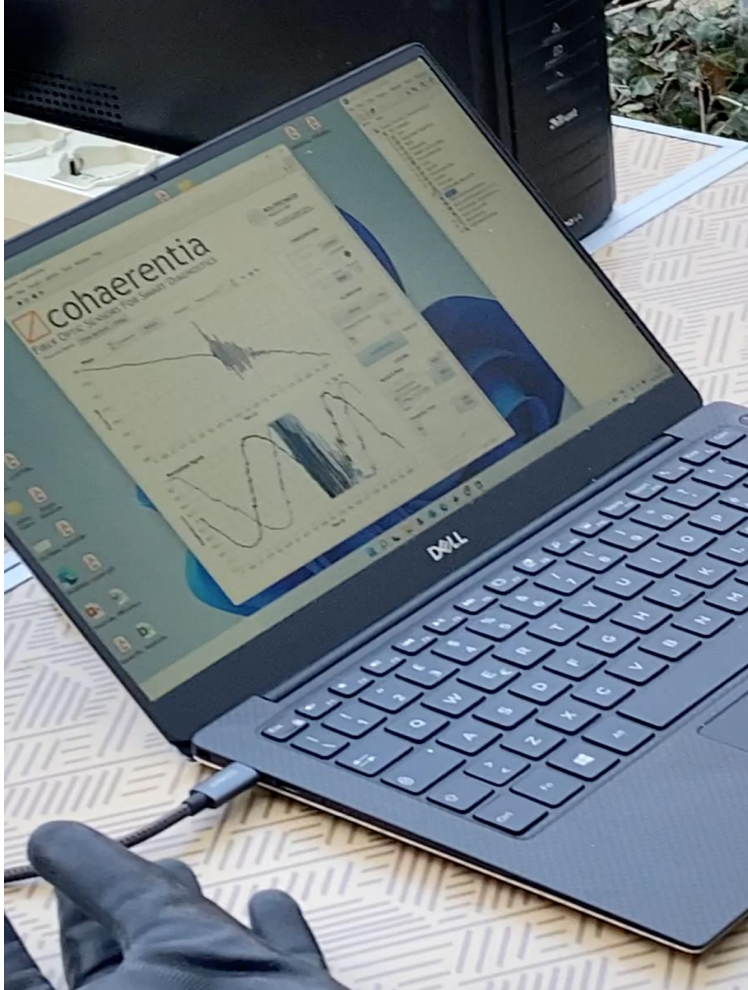
OPTICAL FIBERS ALREADY INSTALLED ALONG THE RAILWAY TRACK ARE USED AS SENSORS TO DETECT ROCKFALL EVENTS.

OPTICAL FIBER CABLES
INSIDE THE DUCT.

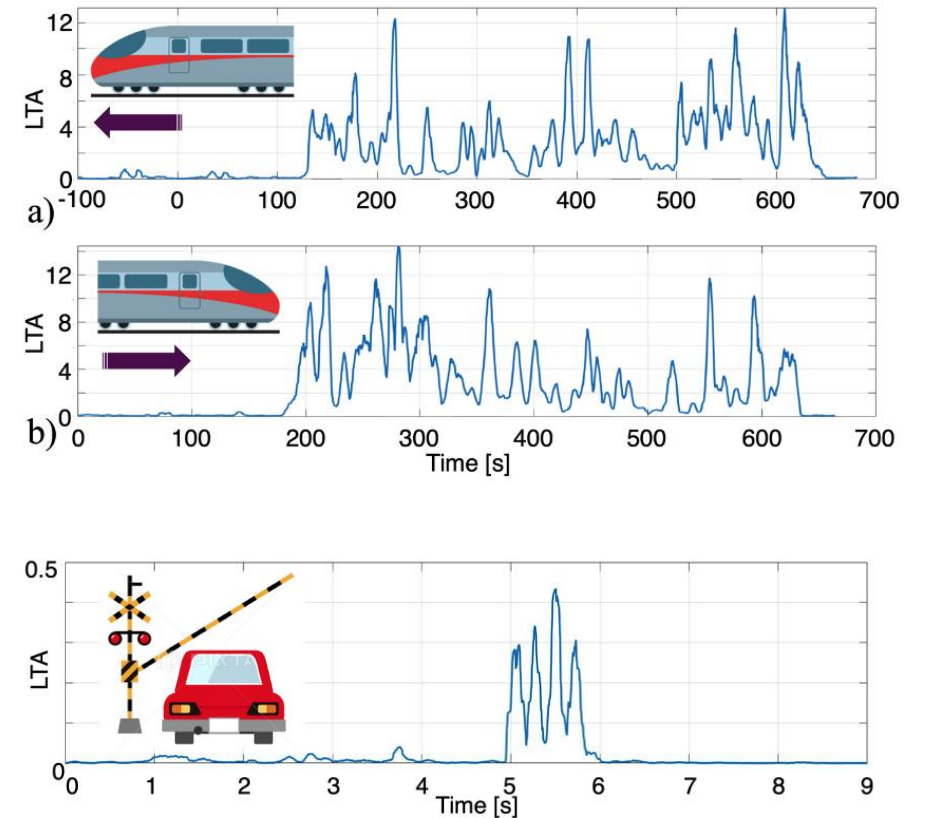
THE OPTICAL SYSTEM INSTALLED ALONG THE RAILWAY DETECTS FALLING ROCK PHENOMENA, THE PASSAGE OF TRAINS AND CARS PASSAGES AT LEVEL CROSSINGS.

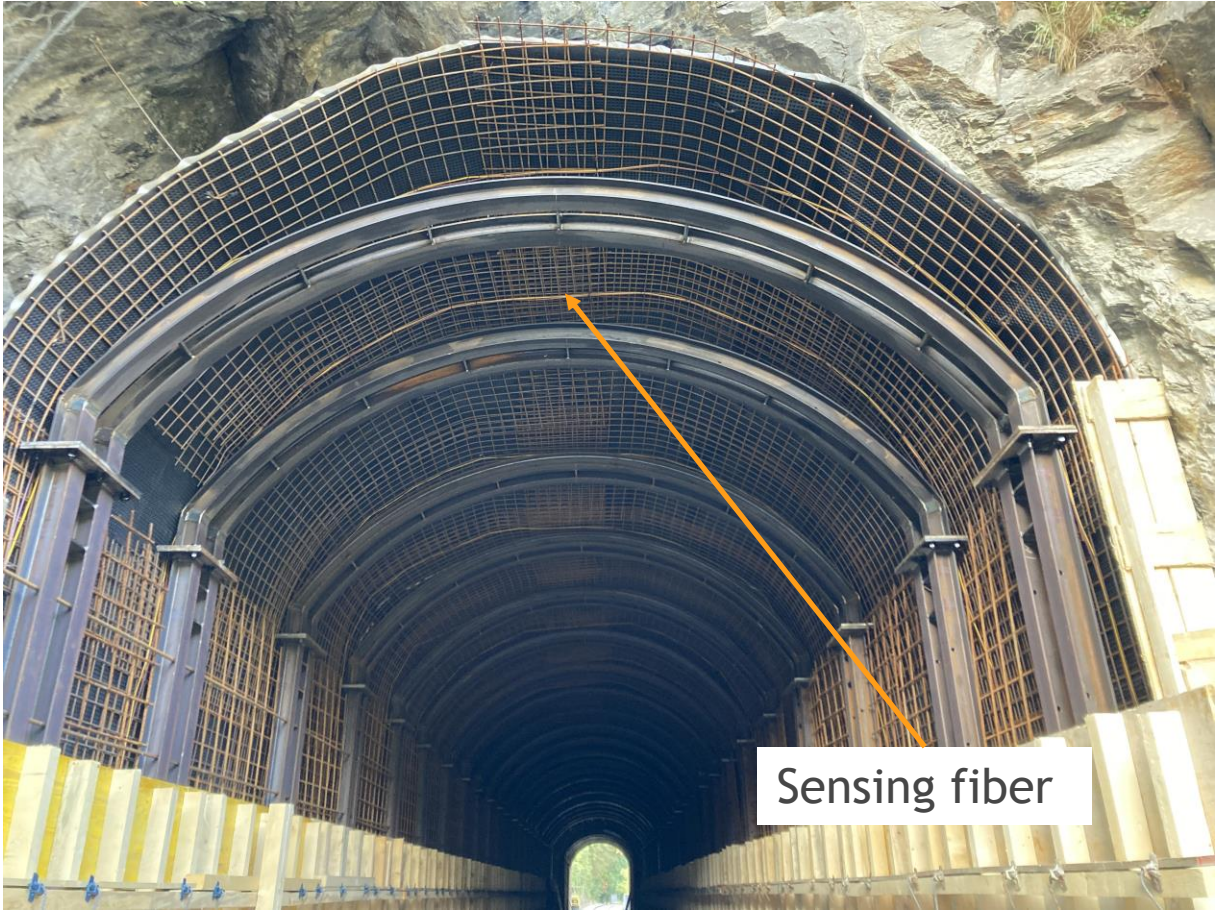
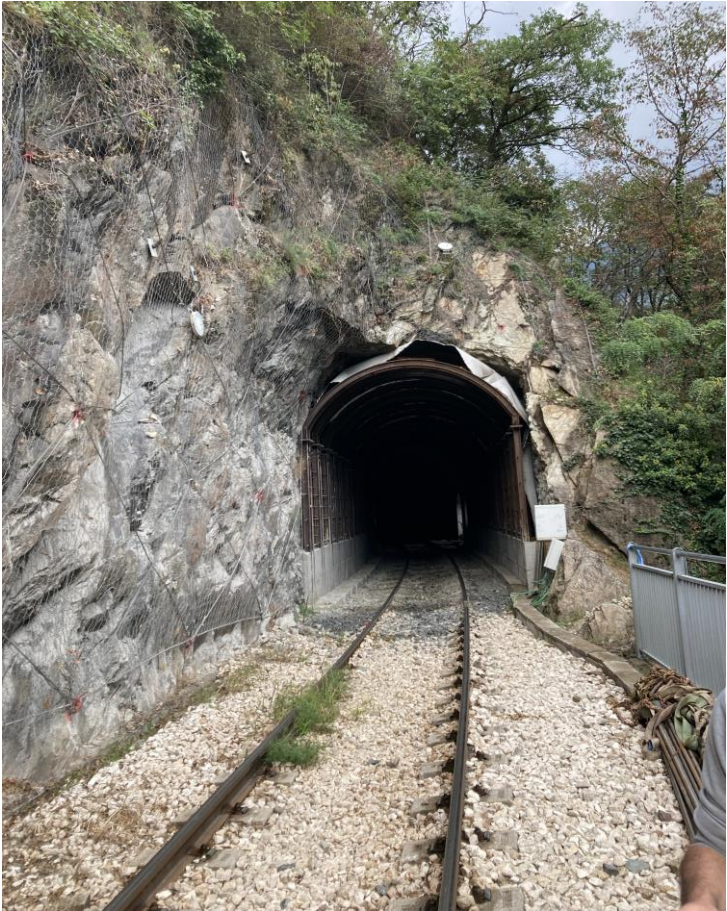
MONITORING OF DEFORMATIONS CAUSED BY GEOLOGICAL MOVEMENTS ON RAILWAY TUNNELS, THROUGH SENSING FIBERS INSTALLED ON METAL RIBS.

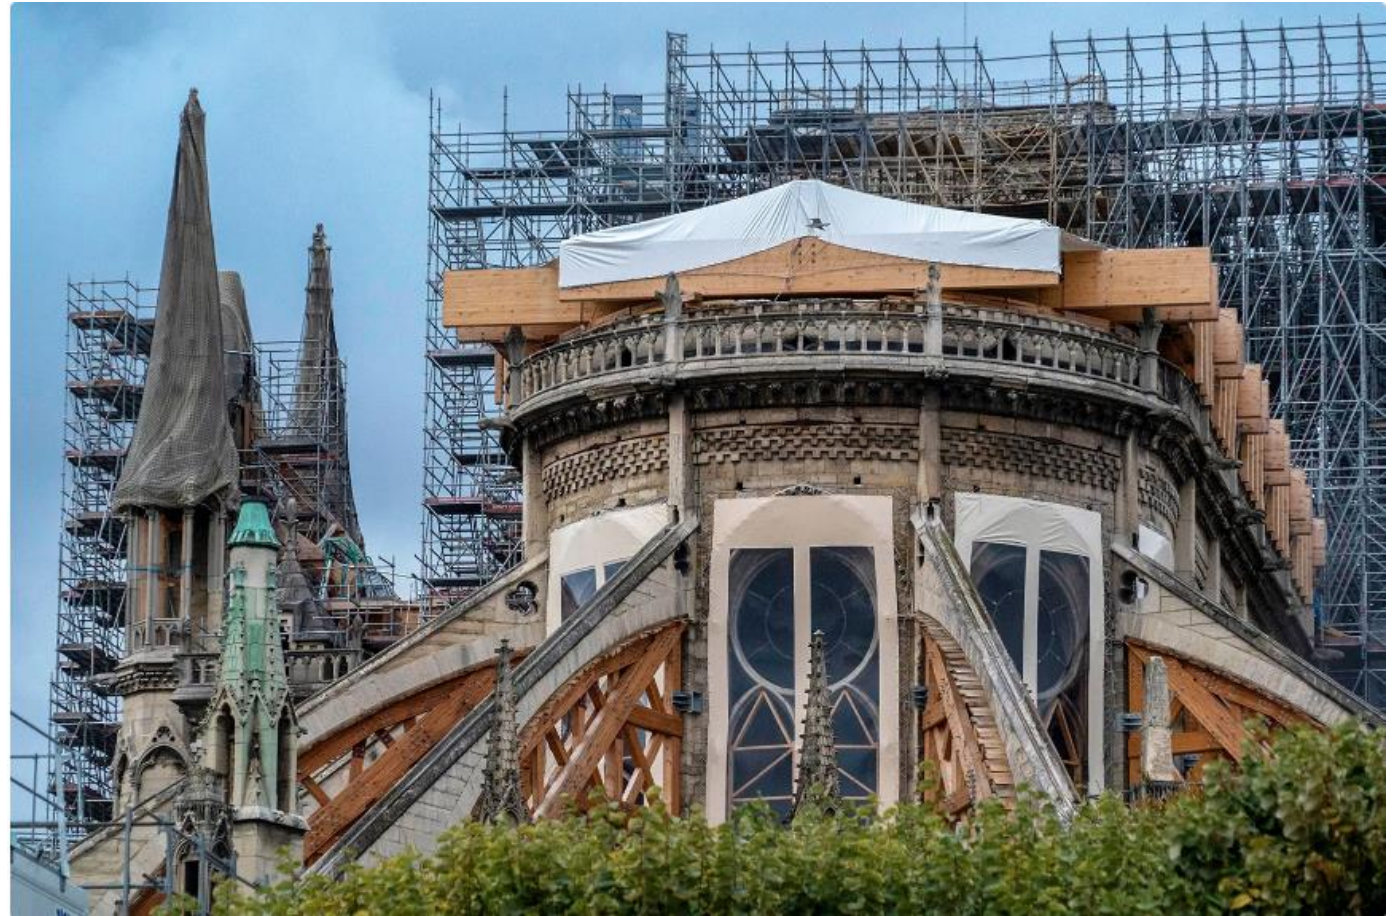
STRUCTURAL HEALTH MONITORING OF HISTORICAL MONUMENTS

CLASSIC TECHNIQUES FOR CULTURAL HERITAGE CONSERVATION REQUIRE OPERATORS ON SITE ASSIGNED TO CONTROL, BUT USUALLY IT IS ONLY TO PROVE A DAMAGE THAT HAS ALREADY OCCURRED.

FIBER OPTIC SENSORS CAN INSTEAD GUARANTEE A REAL-TIME CONSTANT MONITORING AND PROTECTION AGAINST THE LONG-TERM EFFECTS OF POSSIBLE RISK FACTORS.

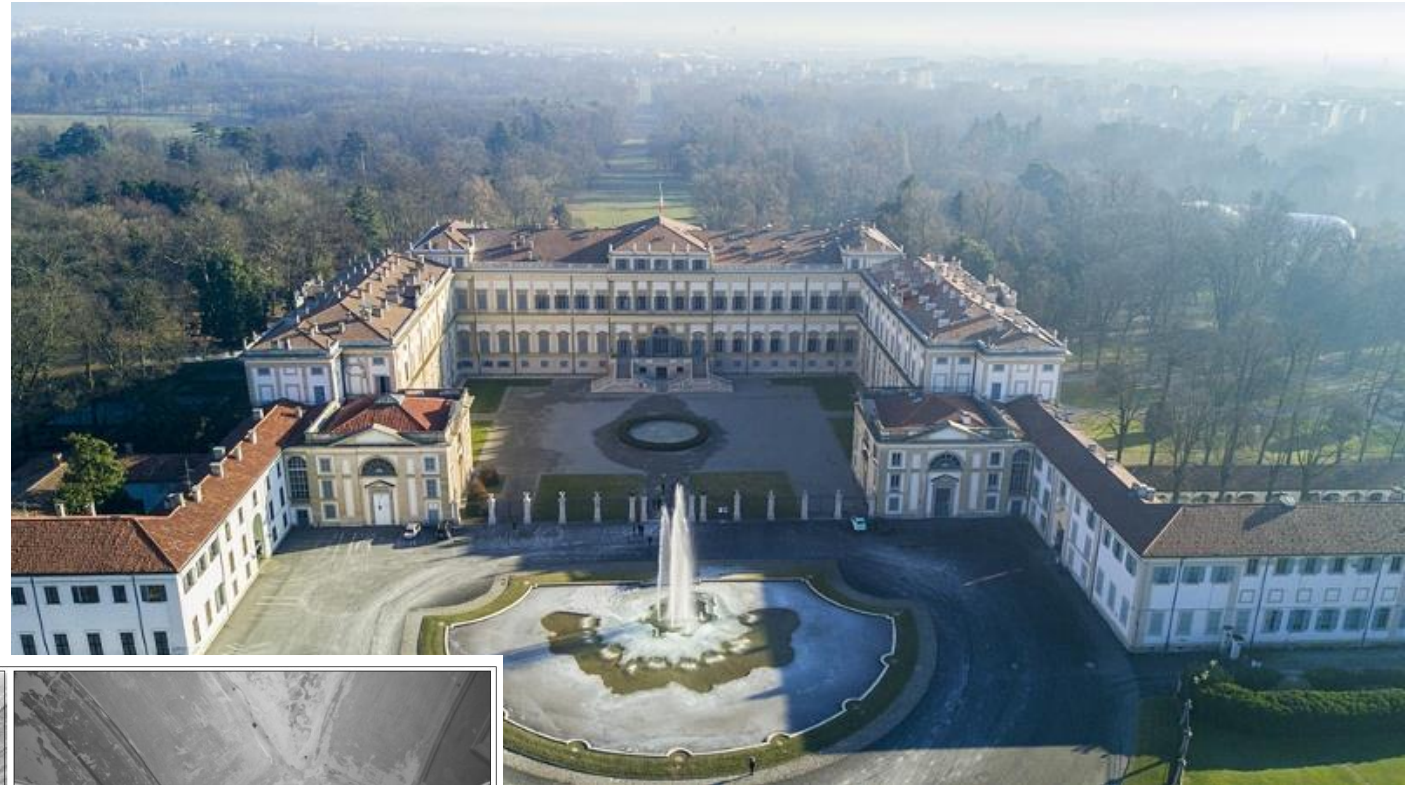
VILLA REALE IN MONZA

IN THE EARLY 2000s, FIBER OPTICS WERE INSTALLED AS STRAIN GAUGES TO MONITOR THE PROGRESS OF CRACKS AND THE RELATIVE DISPLACEMENT OF OPPOSITE WALLS.

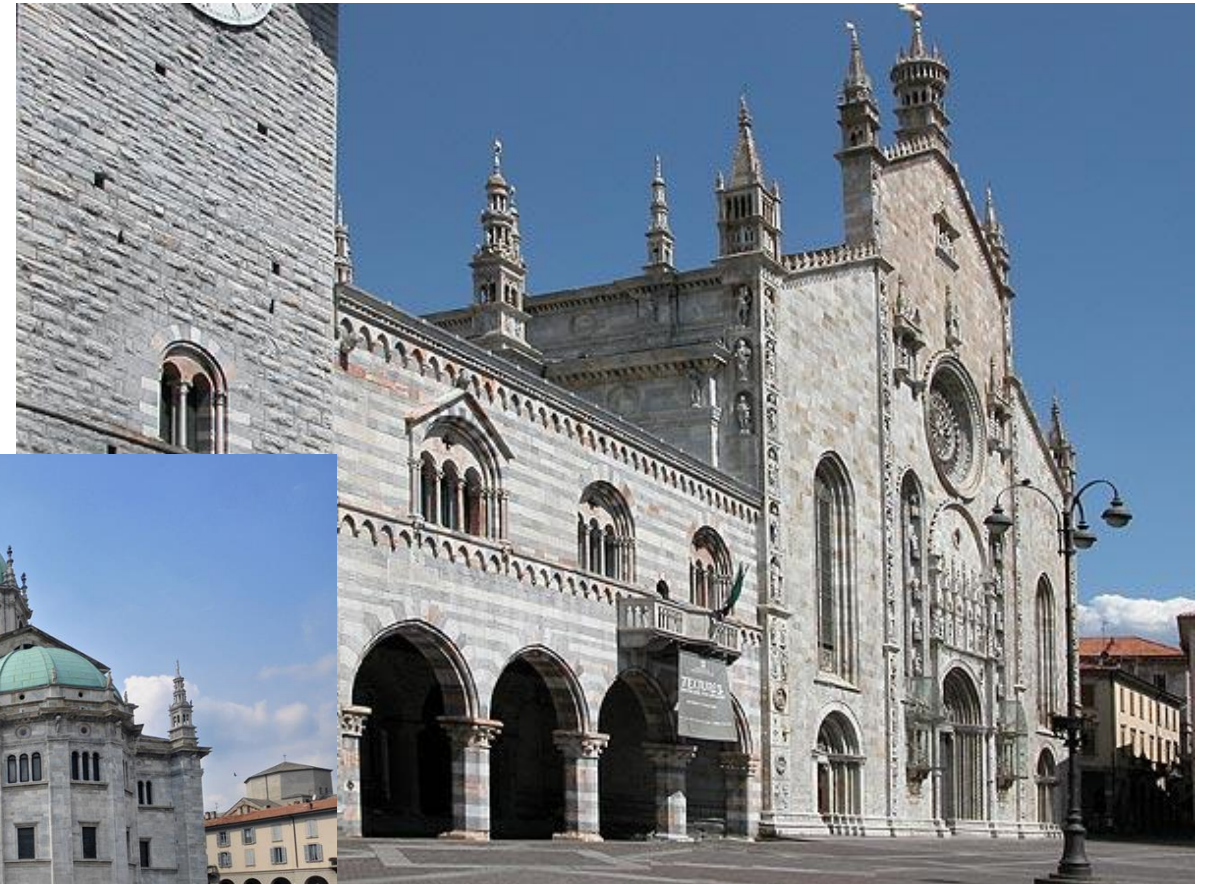
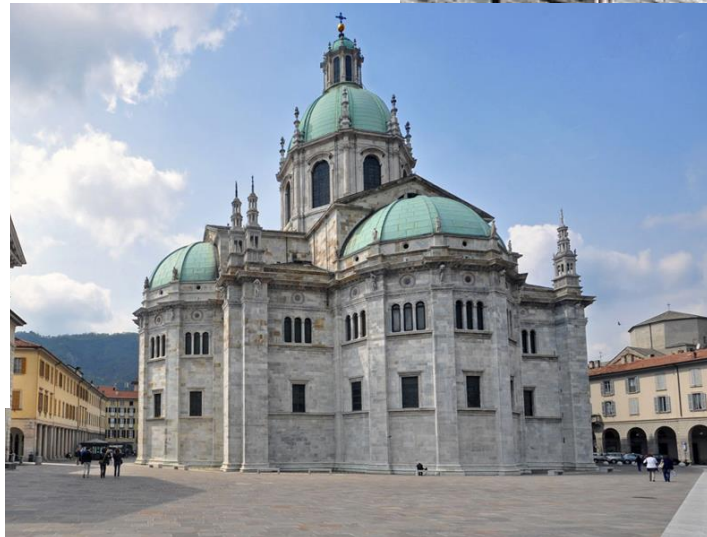
IN 2001, FIBER OPTIC LINES WERE INSTALLED ABOVE AND BELOW THE PRIMARY ARCH OF THE CATHEDRAL OF COMO TO IDENTIFY ANY STRUCTURAL DETERIORATIONS, TO PROTECT THIS IMPORTANT CULTURAL HERITAGE BUILT IN 1396.

- OPENING OF CRACKS;
- DISPLACEMENTS BETWEEN THE 4 COLUMNS THAT SUPPORT THE DOME;
- DEFORMATIONS AND TEMPERATURES IN SELECTED POINTS

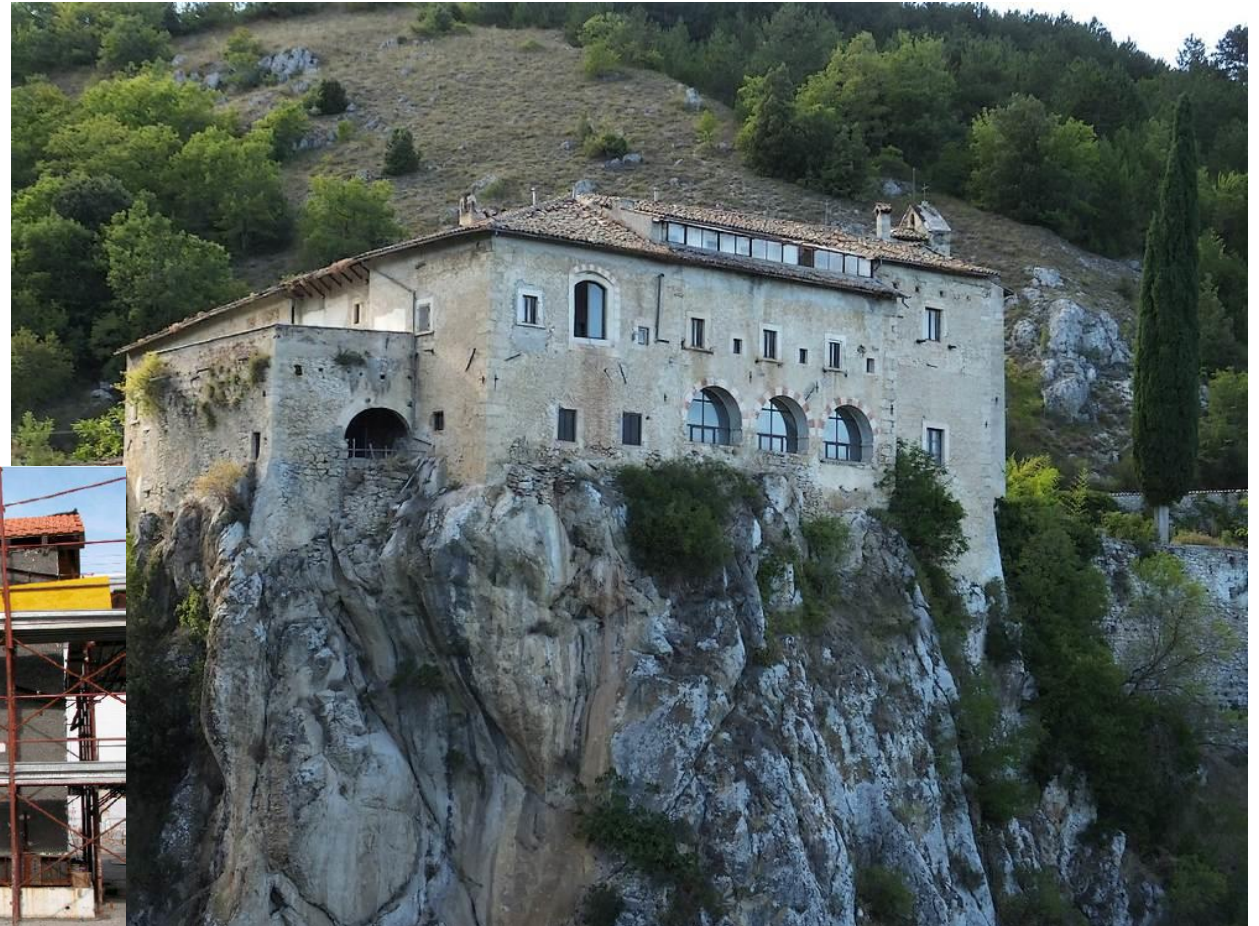
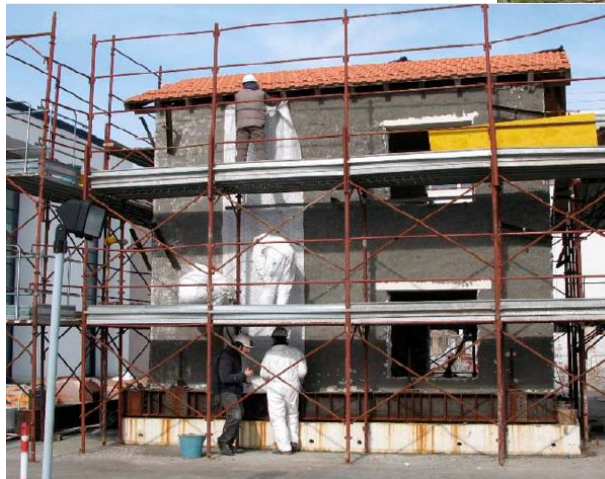
EU PROJECT POLYTECT

SMART TEXTILES WITH EMBEDDED FIBER OPTIC SENSORS IS A COST-EFFECTIVE SOLUTION TO REINFORCE AND, AT THE SAME TIME, MONITOR MASONRY AND HERITAGE STRUCTURES, SUPPORTING THE ASSESSMENT OF THE STATE OF THE STRUCTURE AFTER AN EARTHQUAKE.

THESE SMART TEXTILE HAS BEEN DEPLOYED TO STRENGTHEN AND MONITOR SOME VAULTS AND MASONRY BUTTRESSES OF THE MONASTERY OF SANT'ANGELO D'OCRE, L'AQUILA.
